A Naval Safety Center Publication

# approach

APRIL 1972 / THE NAVAL AVIATION

# STACK against THE an ODDS: accident!

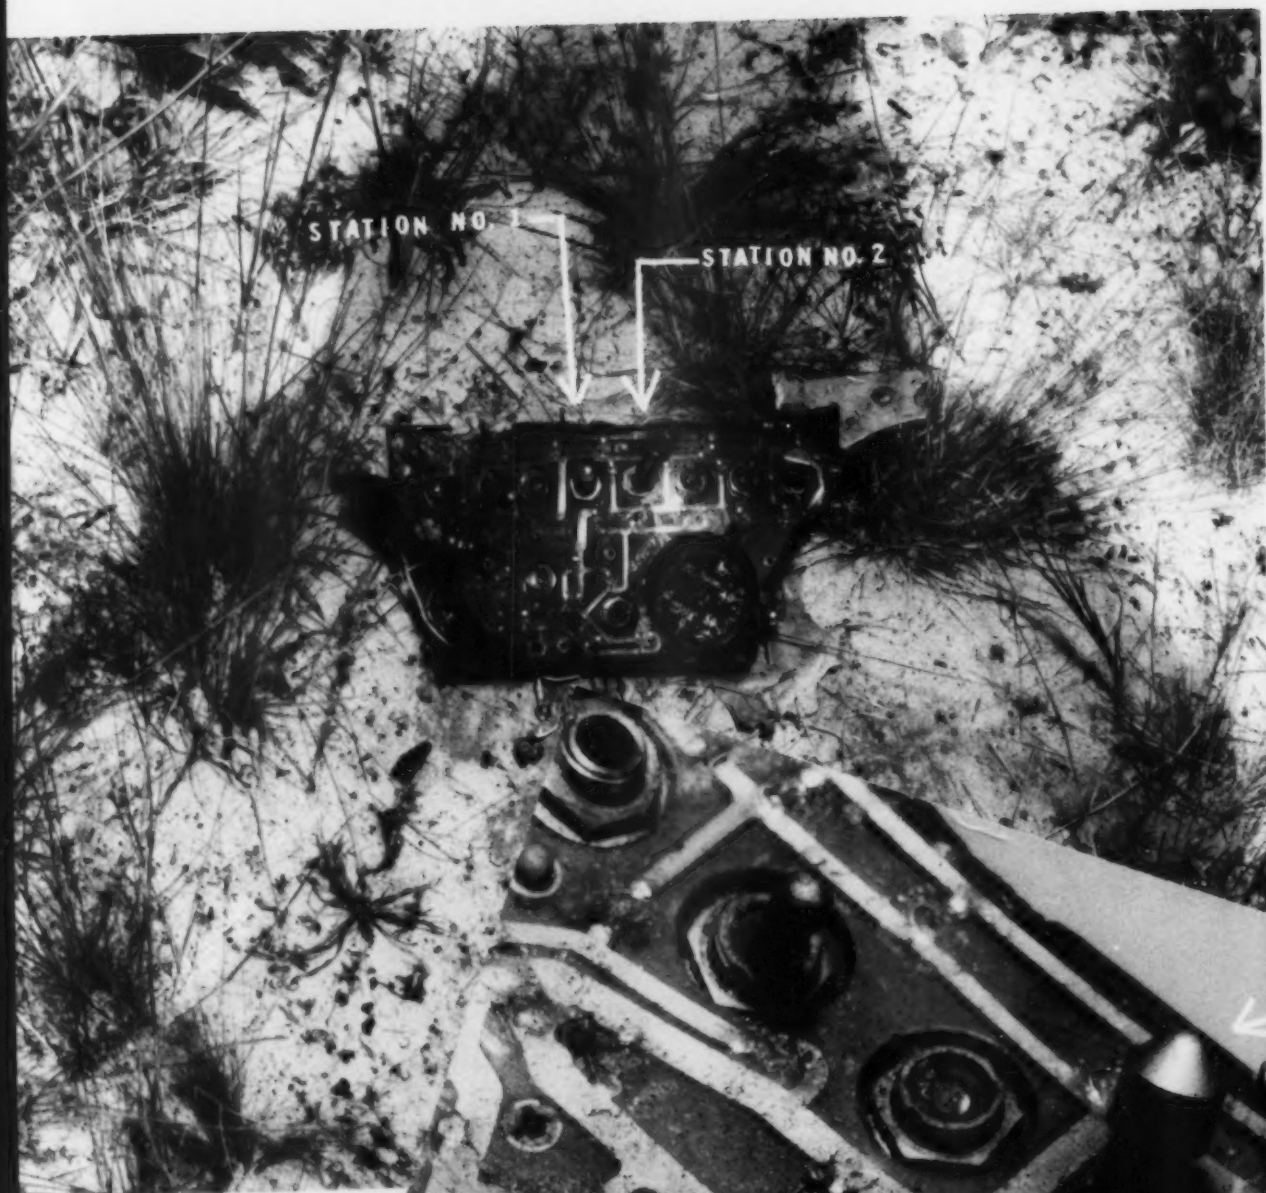
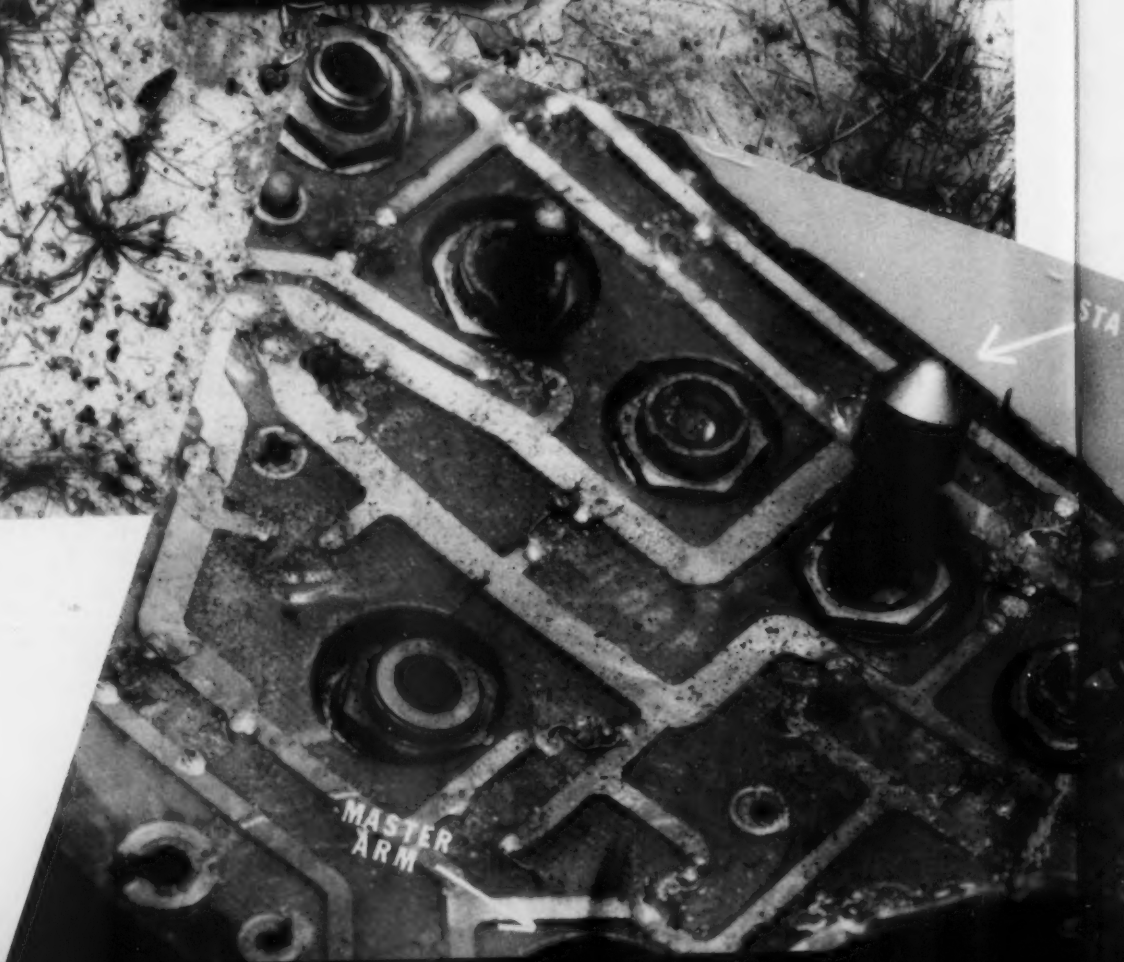
Closeup view shows different station selectors.

The most probable reason was the existing switch configuration on the ordnance panel. That is, the switches for station two through five were a new type which featured a rotary locking knob on the end of each switch (see photos at beginning of article). Station one, however, had a standard lift-to-unlock toggle switch. This unusual configuration came about in this manner: AFC (Airframe Change) 438 of 27 Oct 1969 directed that all station select switches be changed to the type which feature the rotary locking knob. This was done; however, at some later date, it became necessary to replace the switch for station one. The IPB (Illustrated Parts Breakdown) was consulted for switch nomenclature and part number. The IPB still referenced the old standard lift-to-unlock switch, and this was the switch ordered and installed in the panel. A check of the IPB after the accident showed that the information pertaining to the switch had not been updated since the issue of AFC 438.

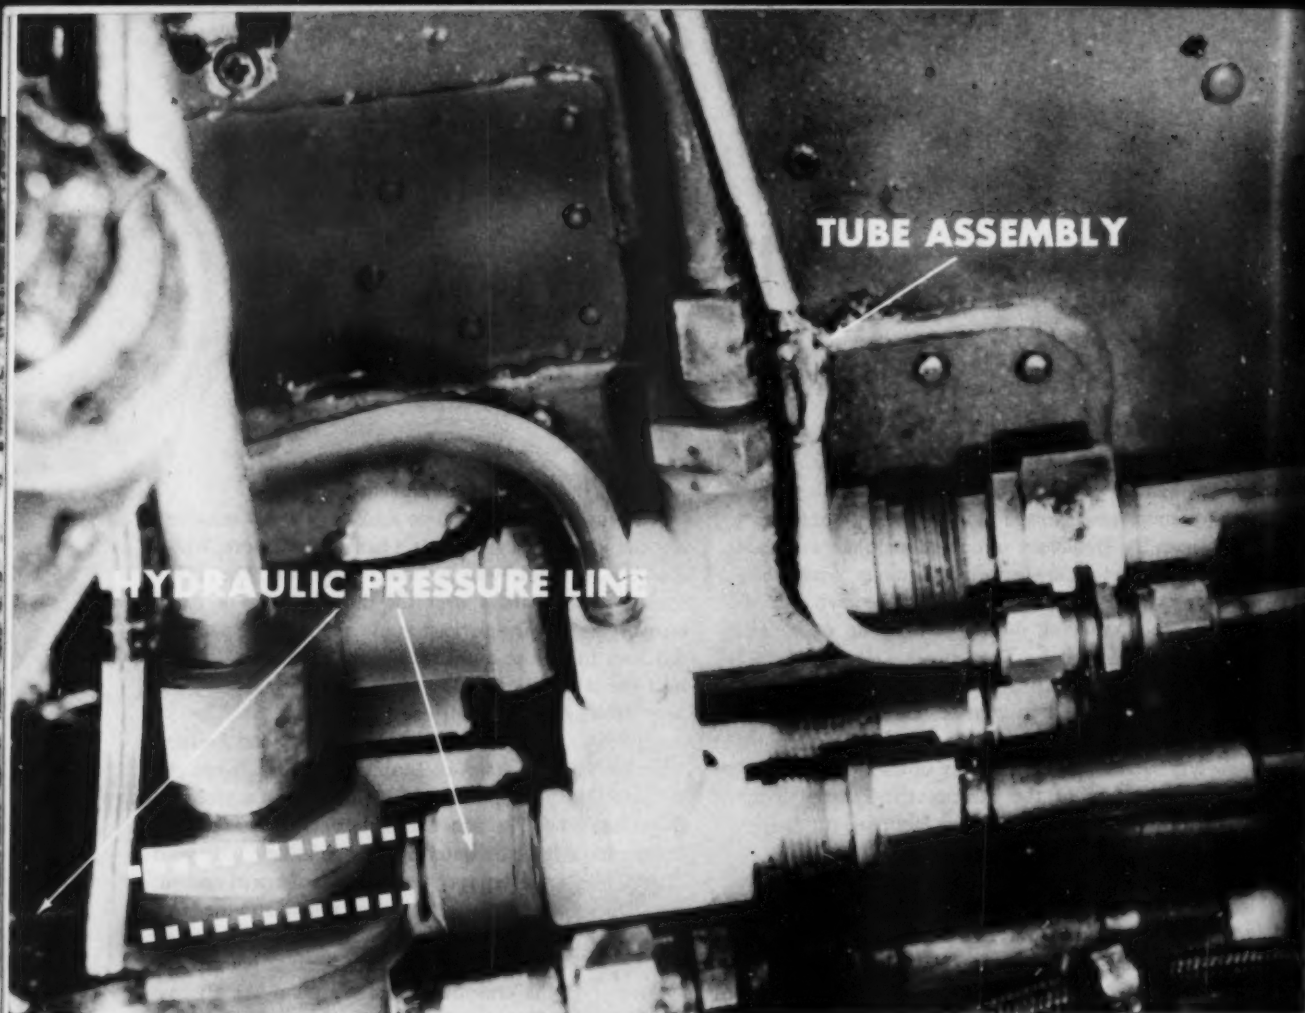
Portion of H-2 main hydraulic system installation

After landing, strong electrical fumes were noted and, the HAC secured the generator and battery. The fumes were caused by a burned out hydraulic pump. The wild gyrations had been caused by the failure of the hydraulic pressure line which was worn through by chafing against the union. (Bottom left corner of photo.) It was also noted that the tube assembly (center of photo) was distorted (most likely by being used as a step). It could

not be determined exactly when the tube assembly had been damaged.

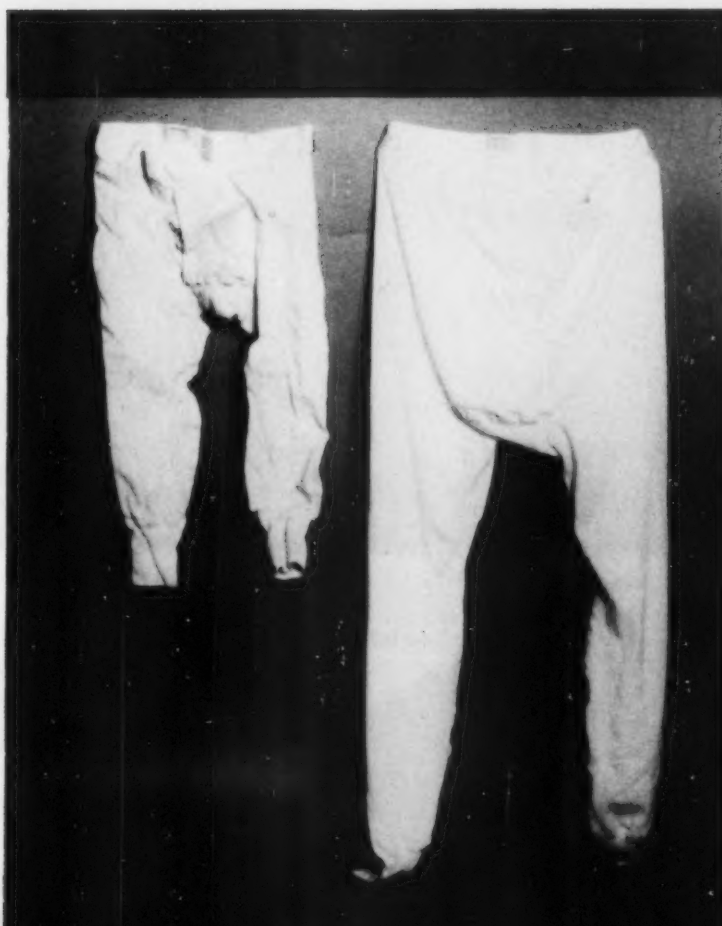
*Before and After:* On the right is a pair of Rhovyl Clervyl T polyvinyl chloride (PVC) drawers designed to be worn under the ventilated wet suit coverall. On the left is a similar pair after a pilot accidentally sent them to the ship's laundry. He tells us they not only shrank to midget size but are now hard instead of soft.

NAVAIR 13-1-6.7, Aircrew Personal Protective Equipment Manual points out that the PVC underwear must be washed as a wool item in water at a mild temperature. The garment can be tumbled dry at a low heat setting. (Hanging the drawers to dry stretches them.) The manual warns that, as the owner of the outfit pictured above learned the hard way, PVC underwear washed incorrectly will be unwearable.
